NONWOVEN PAVING FABRICS STUDY
FINAL REPORT

Industrial Fabrics Association International
Geotextile Division

Maxim Technologies, Inc.
4150-B Freidrich Lane
Austin, Texas 78744

December 1997

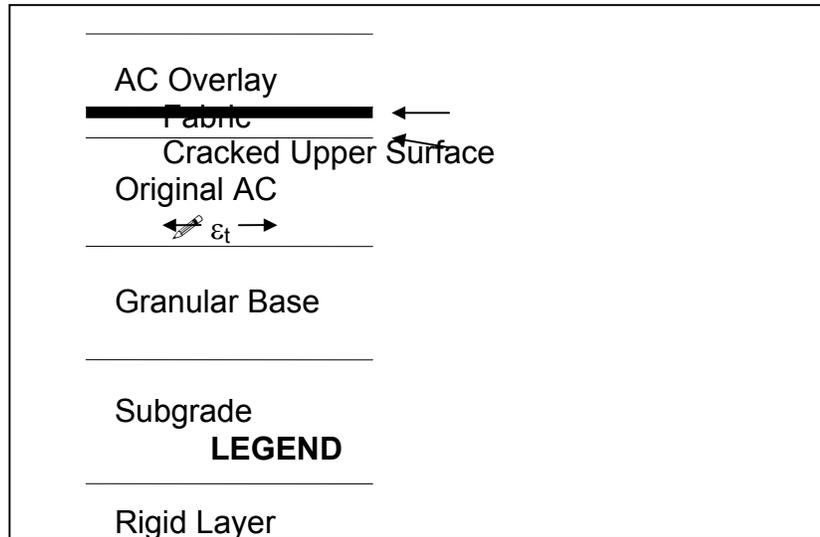
Sketch 1. Structural Model

MODEL SOLVED FOR F_L (FATIGUE LIFE) TO BE EQUAL
 (i.e., $\epsilon_t = \epsilon_t'$ thus $T_{ol} < T_{ol}'$)

Layer	Model without Fabric		Model with Fabric*	
	Thickness	Modulus	Thickness	Modulus
AC Overlay	$T_{ol} = 2-6''$	$E_0 = 500 \text{ ksi}$	$T_{ol}' < T_{ol}$	$E_0' = E_0$
Fabric	N/A	N/A	$T_f = 0.15''$	$E_f' = 5 \text{ ksi}$
Cracked Upper Section	N/A	N/A	$T_{top}' = 0.25''$	$E_{1top}' = 750 \text{ ksi}$
Original AC	$T_{orig} = 2-6''$	$E_1 = 500 \text{ ksi}$	$T_{orig}' + T_{top}' = T_{orig}$	$E_1' = E_1$
Granular Base	$T_{base} = 6''$	$E_2 = 25 \text{ ksi}$	$T_{base}' = T_{base}$	$E_2' = 2 * E_2$
Subgrade	$D_{rl} = 5-30'$	$E_3 = 2.5-15 \text{ ksi}$	$D_{rl}' = D_{rl}$	$E_3' = 2 * E_3$

* Improved soil support provided by moisture control offered by fabric.

1. The Structural Design Model - Accounts for the equivalent thickness contribution of paving fabrics. Sections with and without fabric are modeled to provide an equal performance (fatigue life).
2. The Environmental Design Model - Accounts for the equivalent thickness contribution of paving fabrics. Sections with and without fabric are modeled to provide an equal serviceability - performance life (number of 18 kip ESAL to deteriorate from Initial Present Serviceability Index to Terminal Present Serviceability Index).

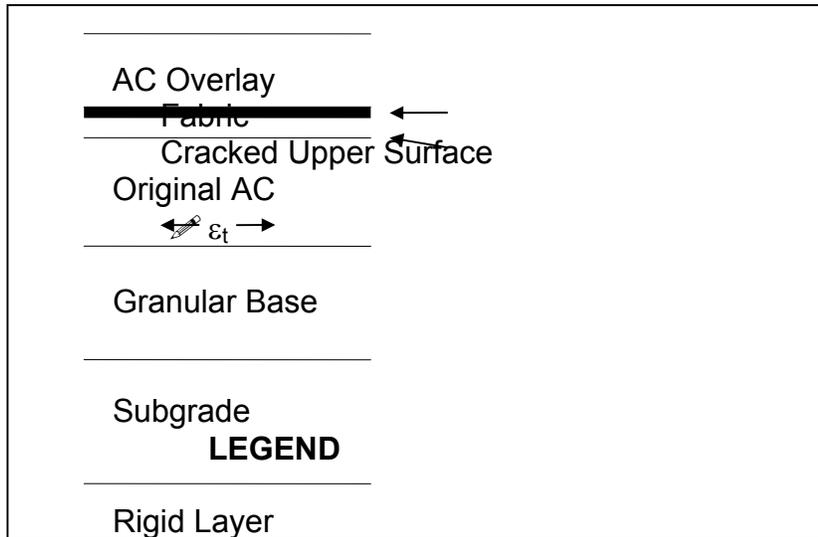
Sketch 2. Environmental Design Models

MODEL SOLVED FOR N_{ESAL} to $p_i=2.5$ EQUAL SERVICEABILITY LOSS
 (considering AASHTO Soil Swelling and Heaving algorithms)

Layer	Model without Fabric		Model with Fabric ^{*1}	
	Thickness	Modulus	Thickness	Modulus
AC Overlay	$T_{ol} = 2-5''$	$E_0 = 500 \text{ ksi}$	$T_{ol}' = T_{ol}$	$E_0' = E_0$
Fabric	N/A	N/A	$T_f = 0.15''$	$E_f' = 5 \text{ ksi}$
Cracked Upper Section	N/A	N/A	$T_{top}' = 0.25''$	$E_1' = 750 \text{ ksi}$
Original AC	$T_{orig} = 2-6''$	$E_1 = 500 \text{ ksi}$	$T_{orig}' + T_{top}' = T_{orig}$	$E_1' = E_1$
Granular Base	$T_{base} = 6''$	$E_2 = 25 \text{ ksi}$	$T_{base}' = T_{base}$	$E_2' = 2 * E_2$
Subgrade ^{*2}	$D_{rl} = 5-30'$	$E_3 = 2.5-15 \text{ ksi}$	$D_{rl}' = D_{rl}$	$E_3' = 2 * E_3$

^{*1} Improved soil support provided by moisture control offered by fabric.

The environmental design module for paving fabric applications in AC overlays is based on the AASHTO pavement design serviceability concept, as a function of road roughness (i.e. slope variance), because of the major impact of a number of environmental parameters (Figure 13). The other parameters involved in the AASHTO flexible pavement serviceability concept i.e., cracking and patching, as well as rutting, are principally load induced phenomenon and are believed to be addressed in the structural design model. The installation of a paving fabric reduces the infiltration of surface water and maintains the moisture contents at or near existing levels. This combination of benefits offers significant control of the subsequent amount of soil swell, shrinkage and heave and, by inference, the amount of road roughness (i.e. slope variance). The basic approach used in this module consists of the definition of equivalent designs with reduction in the required AC overlay thickness with the addition of a paving fabric.
